Manhole Inspection Summary

Manhole # S31SS_018MH

Insp Date: **4/30/07 12:39 PM**

Location Address: **2658 HUNTINGDON AVE**

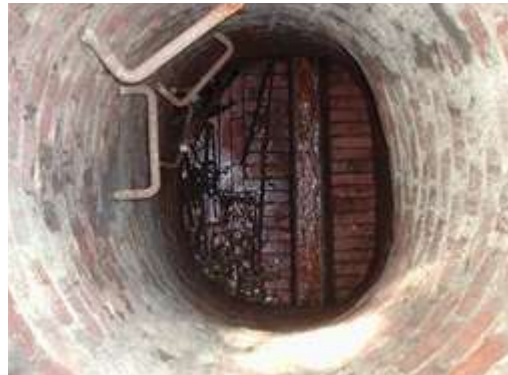
Top View

☐ Parged ☒ **Debris** (not Condition related)

Steps Count: **5** Missing: **0** ☒ **Corroded**

Corroded steps. Bench debris.

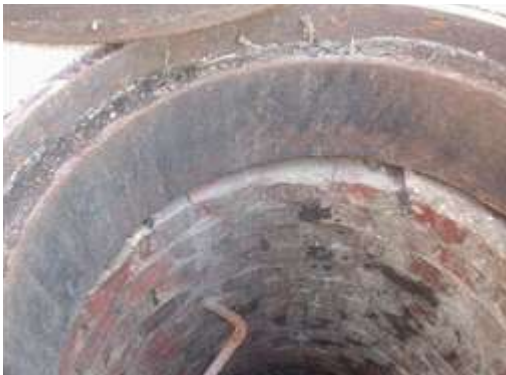
Defect

Condition: ☐ Sound ☐ Cracked ☐ Root Intrusion ☐ Loose Brick ☒ **Deteriorated**

Infiltration: ☐ None ☒ **Joint** ☐ Cracks ☒ **Mortar** ☐ Roots ☐ Wall

Adjustment deterioration and infiltration - other side.

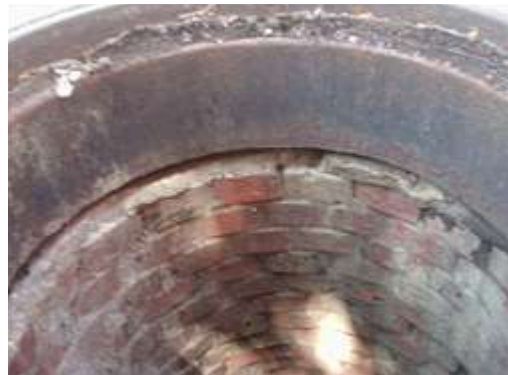
Defect

Adjustment deterioration and infiltration.

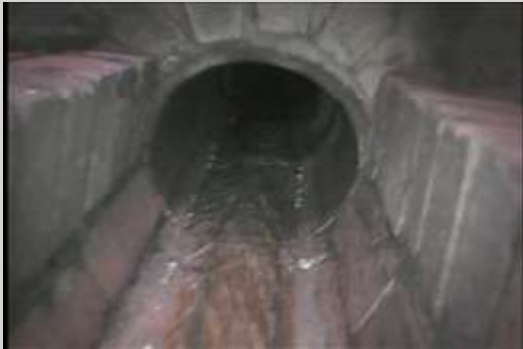
8 in. Circular Gravity Sewer Pipe Out @ 12 O'Clock

Infiltration: **Evidence** Pipe Seal Cond: **Unknown**

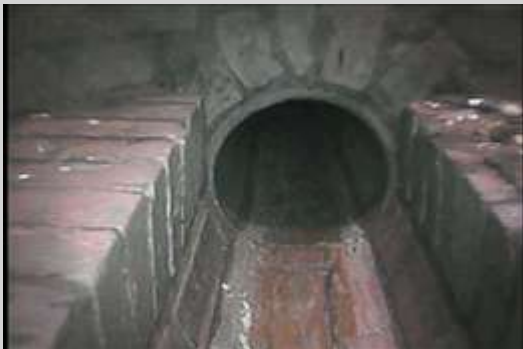
8 in. Circular Gravity Sewer Pipe In @ 6 O'Clock

Infiltration: **None** Pipe Seal Cond: **Unknown**
